Nuclear Energy and Technology 1 (2015) 68–73

Analysis of damaged welds no. 111 in the PGV-1000 steam generator and damage repair proposals

V.P. Povarov*

Novovoronezh NPP, a Branch Department of JSC “Rosenergoatom Concern”. 396072, Novovoronezh, Voronezh Region, Yuzhnaya 1 industrial estate, Russia

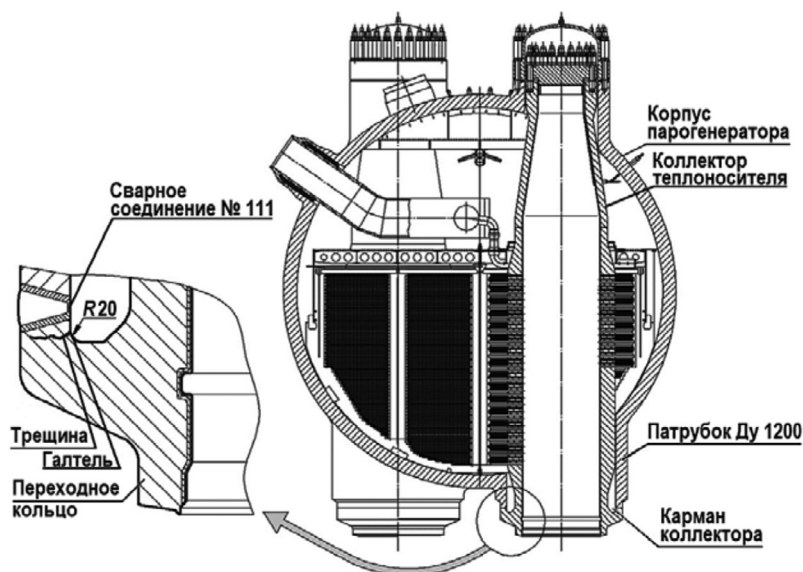
Fig. 1. PGV-1000 M steam generator.

The reliability of the VVER-1000 NPP's main equipment, specifically in conditions of an extended service life, depends on the reliability of its individual components. The most critical item for the VVER-1000 steam generators (SG) is the welded joint between the primary coolant “hot” header and the steam generator vessel's Dn1200 nozzle (Fig. 1).

Сварное соединение № 111 = Welded joint 111
 Корпус парогенератора = Steam generator vessel
 Коллектор теплоносителя = Coolant header
 Трещина = Crack
 Галтель = Fillet
 Переходное кольцо = Adapter ring
 Патрубок Дн 1200 = Dn1200 nozzle
 Карман коллектора = Headerpocket

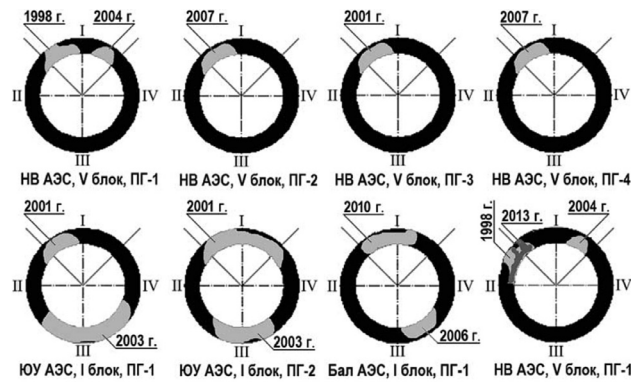
Fig. 2 presents a graphic illustration of the recorded damages to the critical joint, namely the region of the SG hot header welding to the MCP nozzle (WJ 111). Rather long and high crack-like defects, including through-the-thickness defects, have been detected by now in nine SGs of the VVER-1000 NPPs.

As shown by the figure, the initial damage area is directed in all cases towards the MCP hot leg as seen from the short generatrix of the nozzle near the area with the greatest mechanical damage.

During the initial damage, the main crack is directed along the weld and has a great deal of crack kinking. Further defects of the same welds looked differently: there were five knife-like cracks along the nozzle axis (across the weld) on the side opposing the initial defect.

The defect of WJ 111 was caused by corrosion damage to the metal due to intensive corrosive processes resulting in the corrosion pit formation, the effects from heavy tensile loads in the fillet region, and the transcrystalline crack propagation in the

Fig. 2. WJ 111 defect areas: I – short generatrix of the Dn1200 nozzle; II – long generatrix of the Dn1200 nozzle; III – generatrix of the Dn1200 nozzle (that nearest to the “hot” bottom); IV – generatrix of the Dn1200 nozzle (that nearest one to the “cold” bottom).

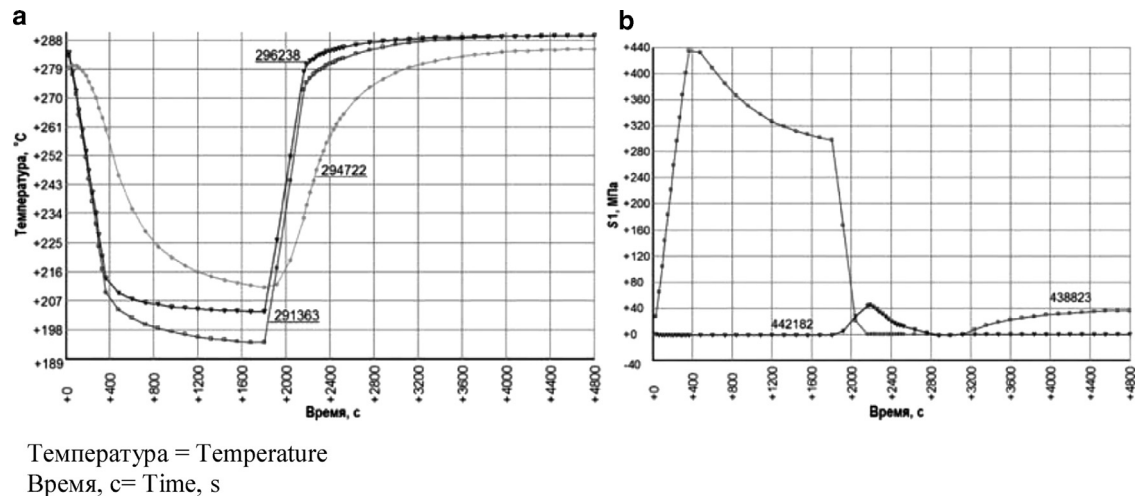
An analysis of the 2011 and 2012 monitoring data shows that all of the temperature anomalies were taking place when the blowdown system was not active. And the most dangerous anomalies during the reactor operation were recorded at working parameters when non-steady-state heat-stress load were superimposed on operating loads. The data obtained allows demonstrating the overall scenario of how temperature anomalies arise: the SG blowdown is not active, all SGs are interconnected through the periodic blowdown header, there is no flow in the blowdown lines of Dn20 and Dn8, the water therein is gradually cooled down (5–10 °C/h), and the amount of "stagnant" water in the blowdown pipeline of one SG is about 1–2 m³. When the pressure is increased in one of the SGs, the chilled water is transferred by pressure into the other SG with a lower pressure via the blowdown lines, and a thermal shock takes place in the region of WJ 111. It is shown in [2] that the highest stress concentration factor is in the fillet radius transition area.

Fig. 3 shows temperature and stress variations in the pocket fillet during a thermal shock [2]. A simulation of the temperature conditions in the region of WJ111 with different temperature variation rates in the fillet area has shown that, at high rates, the material life may be shortened by 10.7% for 1000 cycles only thanks to temperature anomalies.

Fig. 3. Thermal shocks in the pocket fillet area of WJ 111: (a) – temperature variation; (b) – stress variation.

What can be done to exclude beyond-design-basis thermal shocks resulting from the blowdown system operation? This requires the primary circuit hydraulic test procedures to be updated with altering the procedure for switching over the periodic blowdown headers and adding to the safe operation manual instructions on the valve opening (closure) in the periodic blowdown lines. This will lead to a reduced level of the operating heat-strain impacts on the metal of WJ 111 and to a decrease in the damageability level.
